# Bone as a composite material: the role of osteons as barriers to crack growth in compact bone.

O'Brien, F.J.; Taylor, D. and Lee, T.C. Bone as a composite material: the role of osteons as barriers to crack growth in compact bone. *International Journal of Fatigue* 2007 (29): 1051-1056.

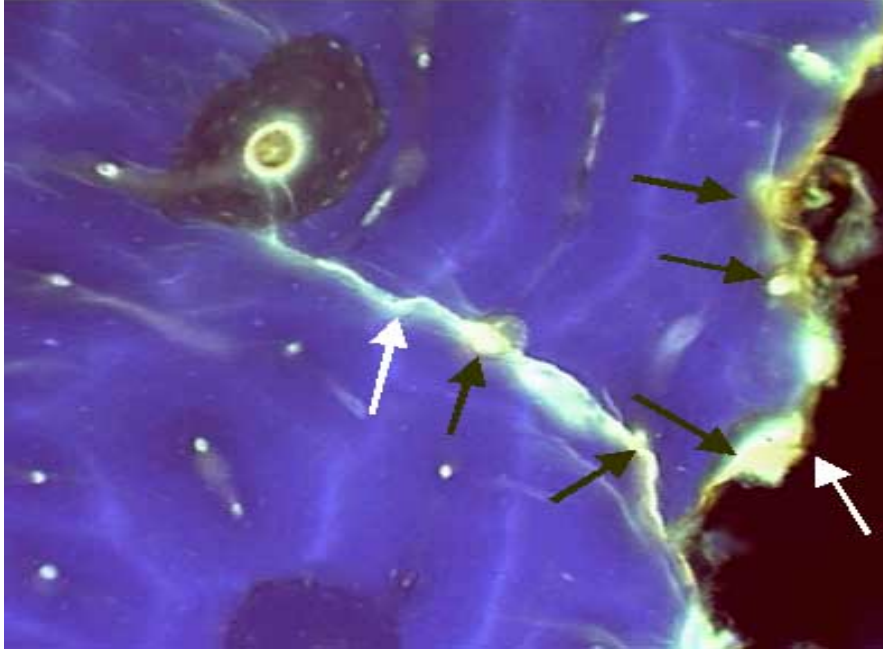
Fig. 5. This illustrates a typical example of two large cracks (white arrows) that were involved in failure of a specimen (the second crack is the main failure surface). As these cracks grew to macrocrack size, they managed to penetrate the cement lines of numerous osteons and used the Haversian canals (black arrows) as weaknesses in which to further propagate.

Failure was observed to occur with the propagation of one, or very few, long cracks to critical lengths, rather than by the coalescence of numerous small microcracks. However, an interesting observation was that these cracks always penetrated a cement line at some stage on the path to failure. Figure 5 shows a typical example of two large cracks that were involved in failure of a specimen. It can be seen clearly that, as these cracks grew to macrocrack size, they managed to penetrate the cement lines of numerous osteons. This was a recurring theme when the fracture surfaces were studied, all failure surfaces showed splitting of osteons usually at the Haversian canals in the centre. These canals provide vascular supply to the bone tissue and are therefore essential to the well-being of the bone tissue. However, as failure tended to occur with the critical growth of cracks which had penetrated cement lines, rather than the growth of cracks which were found in regions of the bone with few secondary osteons, this would suggest that, in the event of microcracks growing to lengths which allowed them to penetrate cement lines, these canals acted as weaknesses in the bone and allowed a pathway for further propagation and eventual failure.
